LSU Health Sciences Center: Preparing for Restoration

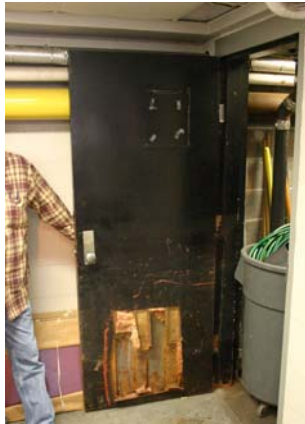
Potential corrosion due to chloride contamination is of particular concern in many of the buildings. For example, the hollow core steel door at the first floor level of a parking garage was more heavily corroded than the similar door at the second floor. It is possible that this heavier level of corrosion is related to the immersion of this door during the flood. Since the interior core of the door is filled with batt insulation, moisture in the core could wick upward, cyclical condensation could occur on the door's interior, and all interior surfaces of the door would be exposed to unusual levels of moisture. The chloride detected here will promote accelerated corrosion of the steel door.

- Where chloride contaminated metal building components such as doors and brackets, the components should be removed and cleaned or replaced
- Plaster finishes should be removed, replaced, and repainted
- Areas of localized paint failure should be cleaned, spot-primed, and topcoated
- Spandrel glass units with delaminated opacifier film should be replaced
- Localized areas of damaged parging should be replaced
