Moisture and Mold in a Tenant Improvement

The Problem

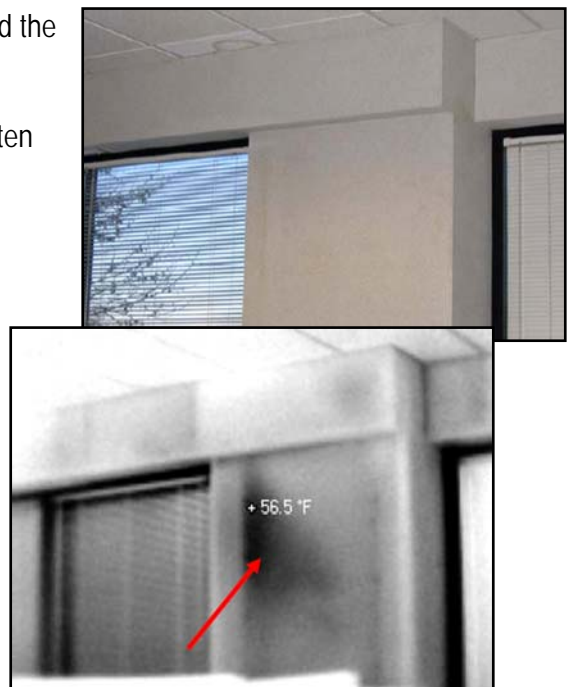
In some areas along base drywall, suspected biological growth was observed. Although elevated moisture levels did not register on the moisture meter, thermal differences were observed in the infrared thermograph.

Immediate results: Infrared thermographs identified potential moisture in several areas where no mold growth was visually observed or registered by moisture meters.

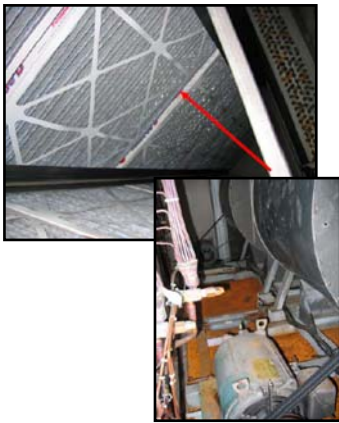
No overt biological growth was observed in the air handling systems. All other areas in which airborne samples were collected did not indicate the spread of the discovered indoor amplification to other non-renovation areas at the time of the sampling. The concentrations and types of spores from the indoor samples were comparable to outdoor baselines and to non-impacted interior controls.

Immediate results: Although no overt biological growth was found in the air handling systems, during the sampling protocol Chelsea Group found some other mechanical concerns:

- Gaps existed between individual filters, and the end caps of the filter racks were missing, allowing particulate build-up on cooling coils, which can lead to increased energy usage.
- The cooling coils and condensate pans were dry at the time, but rusting of the condensate pans was noted. Standing water during the cooling season has the potential to support biological growth.

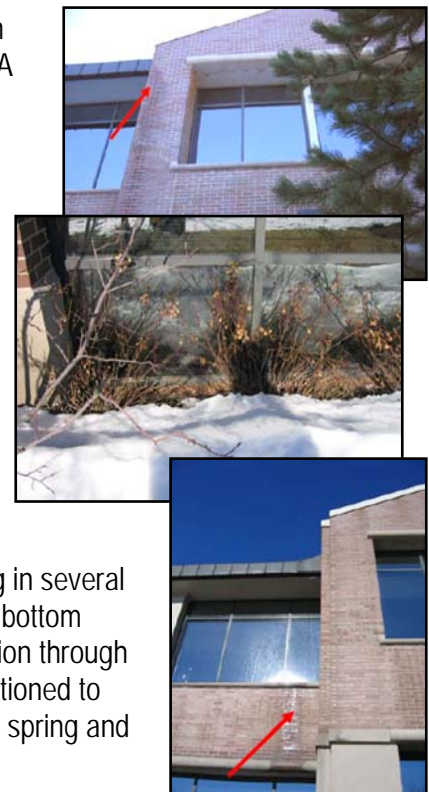
At the time of the site-assessment, water was observed streaming off the roof in sections where sloped roof lines meet. Snow and ice build-up was observed where the two roof lines meet. The building exterior at these areas was water stained, and water was observed pooling near the foundation in some of these areas. In addition, a small gutter system with a heater was observed in two locations to combat the ice damming issues that were reported by the Lead Engineer. Again, water was observed flowing over these drainage systems, down the side of the building.

Landscaping around the building perimeter was sloped towards the building in several locations. In addition, there were areas where the landscaping covered the bottom window flashing and weep holes. These conditions can lead to water intrusion through the building envelope. Some landscaping sprinkler heads were closely positioned to the building exterior, which may be an additional source of water during the spring and summer months.

Immediate results: Chelsea Group recommended:

- Investigate options for proper roof watershed systems to direct rain and melting snow off the roof away from the foundation of the building.
- Re-landscape areas that currently slope towards the foundation of the building to reduce potential of water intrusion.
- Re-locate landscaping sprinklers that spray water on the building.
