## Contemporary Arts Center, the Aftermath of Hurricane Katrina

### The Problem:

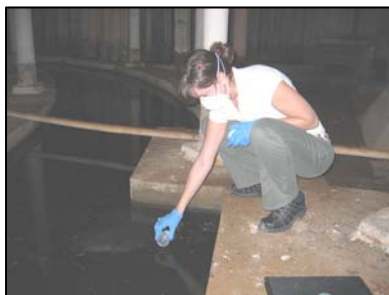
An urgent question in many of the water damage claims resultant of the Hurricane Katrina events was, "Where did the water come from?" Most businesses and residences did not have flood insurance coverage. Therefore, it was necessary to document that the water damage was caused by the wind and rain, rather than floodwater, to receive insurance compensation for the clean-up. Chelsea Group collected water samples in the basement of the Arts Center to determine whether bacteria indicative of wastewater contamination were present.

Results of the water sample analysis were negative for bacteria indicative of wastewater contamination. This showed that the majority of water came from rainwater intrusion through the damaged roof, skylights, and windows, rather than from flooding.

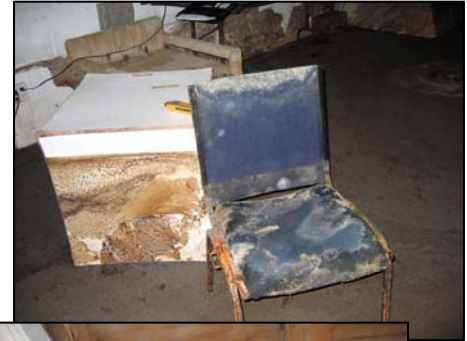
- Relative humidity and dew point measurements were taken to determine potential for condensation, as the space was unconditioned due to damage to the HVAC system.
- A moisture survey of the porous and semi-porous building materials of the facility was conducted using a GE Protimeter moisture meter to determine the extent of moisture damage and to outline a scope of removal work.

The extent of the materials damage was concentrated in the basement, where almost every porous and semi-porous surface was supporting heavy microbial growth. In addition, amplification was observed on the drywall of the atrium.

**Immediate results:** By performing visual inspections and moisture mapping, Chelsea Group was able to determine the extent of the damage to the building and to specify an approach to remediation work.

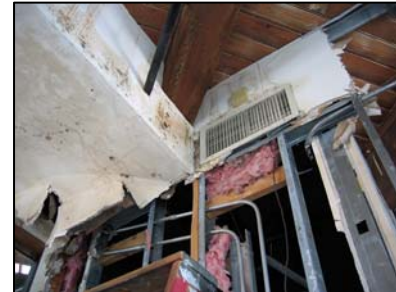
Contaminated areas and materials throughout the basement, 2<sup>nd</sup>, 3<sup>rd</sup>, and 4<sup>th</sup> floors were identified. Chelsea Group provided a specification plan to contain areas during remediation work, protecting clean areas from mold spores and contaminated materials.

Some sections of biologically impacted building materials had been removed before Chelsea Group was contacted. The State of Louisiana requires that workers who provide mold remediation services be licensed. Removal of impacted materials without the use of proper containment and dust-suppression methods can affect workers' health. Also, the protection of the art exhibits from damage from mold growth was a high priority.

**Immediate results:** Chelsea Group provided a remediation specification that outlined the scope of work, proper containment, worker safety, and protection of valuable collections in order to obtain bids from licensed contractors.
