LSU Health Sciences Center: Preparing for Restoration

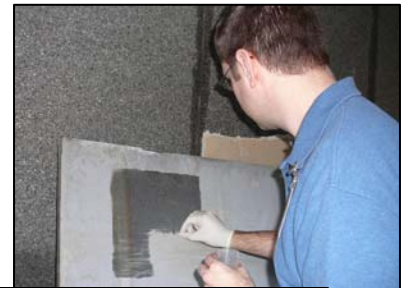
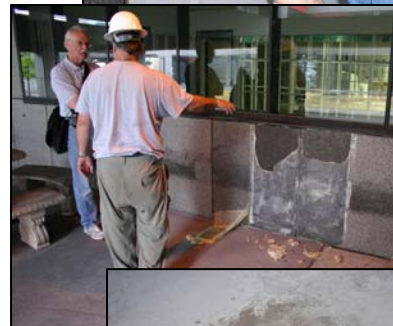
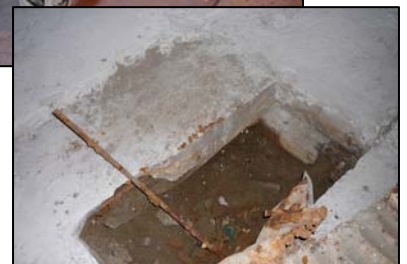
Immediate Results: Tests showed no significant concentrations of chemical contamination, especially related to petroleum, agricultural, or industrial sources. Trace amounts of chromium were detected in a few samples, still significantly below any noted level of concern for this metal. Chloride was found in many areas; because it could cause damage to metal building components, Chelsea Group recommended cleaning or replacement of those components.

Potential corrosion due to chloride contamination is of particular concern in many of the buildings. For example, the hollow core steel door at the first floor level of a parking garage was more heavily corroded than the similar door at the second floor. It is possible that this heavier level of corrosion is related to the immersion of this door during the flood. Since the interior core of the door is filled with batt insulation, moisture in the core could wick upward, cyclical condensation could occur on the door's interior, and all interior surfaces of the door would be exposed to unusual levels of moisture. The chloride detected here will promote accelerated corrosion of the steel door.

- Where chloride contaminated metal building components such as doors and brackets, the components should be removed and cleaned or replaced
- Plaster finishes should be removed, replaced, and repainted
- Areas of localized paint failure should be cleaned, spot-primed, and topcoated
- Spandrel glass units with delaminated opacifier film should be replaced
- Localized areas of damaged parging should be replaced
