Moisture and Mold in a Tenant Improvement

The Problem

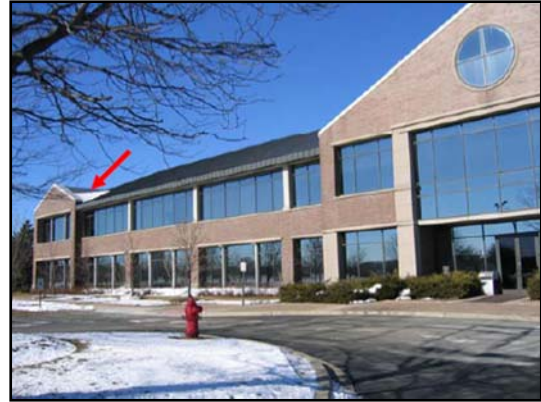
During tenant improvement renovations at a commercial office building located in Buffalo Grove, Illinois, the general contractor discovered mold growth in several locations in the building. The tenant contacted Chelsea Group to conduct a visual observation of the facility with special consideration to areas with reported biological growth, perimeter spaces, and the exterior building envelope.
